2 Introduction

This report presents FEMA's Building Performance Assessment Team's (BPAT) observations on the success and failure of buildings in Puerto Rico to withstand the wind and flood forces generated by Hurricane Georges. In addition, the seismic resistance of some of the buildings observed was assessed. In this report, "buildings" refer to single- and multifamily homes, residential buildings, and commercial and industrial buildings. Recommendations to improve building performance in future natural disasters in Puerto Rico are included. During this building performance assessment, additional consideration was given to mitigation success stories, particularly when mitigation successfully reduced damages. In the context of this document, mitigation is defined as actions taken to prevent building damage and/or minimize the extent and impact of building damage if it occurs.

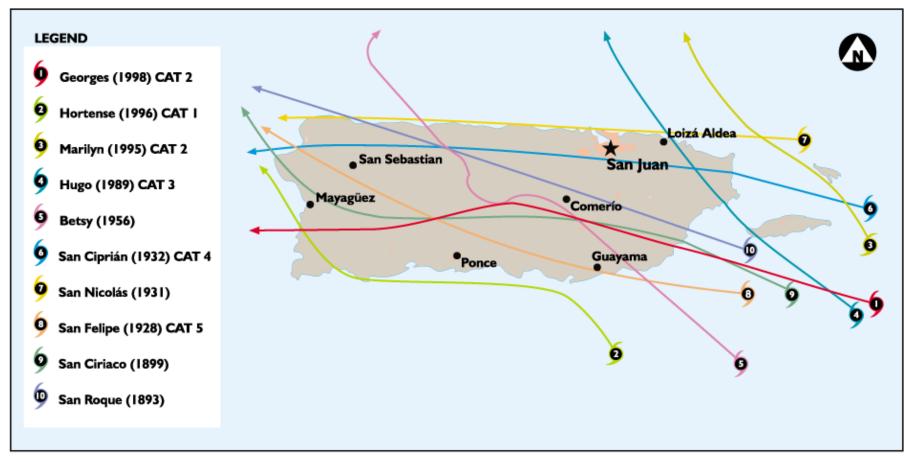
FIGURE 2-1 History of hurricanes in Puerto Rico.

Historical data indicate that the island of Puerto Rico has been struck or otherwise affected by 10 hurricanes since 1893 [Defensa Civil Estatal de Puerto Rico and FEMA 1996]. Their intense rain and devastating wind speeds have caused extensive damage to the island. Figure 2-1 shows the path of these hurricanes. Hurricane category designators in Figure 2-1 (e.g., CAT 2) are based on the Saffir-Simpson scale. Central pressure of the hurricane (measured in millibars) and wind speed (measured in mph as 1-minute sustained) ranges for hurricane categories of the Saffir-Simpson scale are shown in Table 2-1.

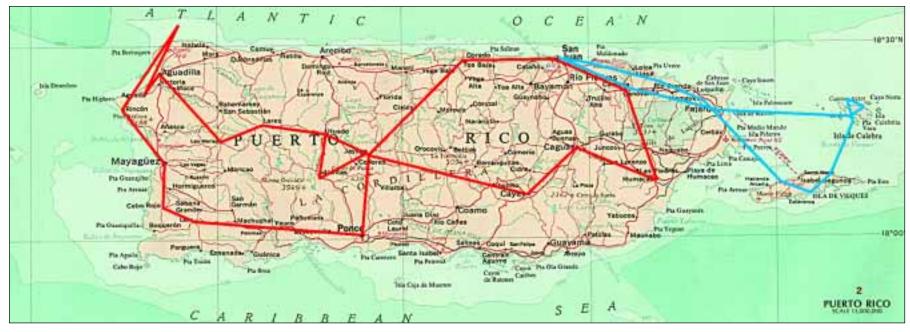
FIGURE 2-2 Flyover routes from October 2 (in red) and October 3 (in blue). Map is not to scale. Source: The Perry Castañeda Library Map Collection.

The BPAT conducted two aerial assessments of Puerto Rico. The first passed through Canóvanas, Humacao, Caguas, Jayuya, Adjuntas, Utuado, Aguadilla, Rincón, Mayagüez, Cabo Rojo, Ponce, and Toa Baja. A second flyover of east Puerto Rico included Fajardo and the two islands to the east: Vieques and Culebra (Figure 2-2).

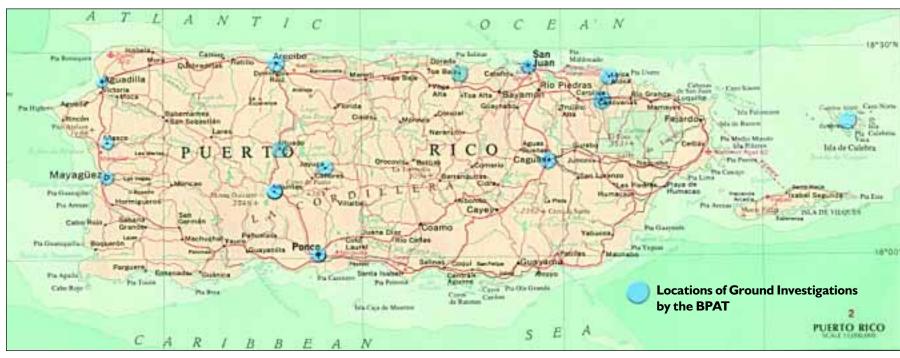
FIGURE 2-3 Locations of ground investigation by the BPAT. Map is not to scale.

On October 6, the BPAT split into two groups, a wind investigation team (Wind Team) and flood investigation team (Flood Team). Ground investigations for both groups included visits to Jayuya, Adjuntas, and Utuado (Figure 2-3). On October 7, the Flood Team continued west investigating coastal and riverine flooding in Cabo Rojo, Rincón, Mayagüez, Aguadilla, and Arecibo. The Wind Team remained in the center of the island north of Ponce to observe wind damage and investigate reports of tornadic activity. On October 9, both teams flew to Culebra to inspect this newly designated FEMA Project Impact community.² The BPAT team completed its deployment on October 10.
